TRANSPORTATION RESEARCH CENTER

ON-SITE AIR BAG INVESTIGATION

CASE NO. - 93-07

The 1990 Dodge Daytona was equipped with a driver supplemental restraint system (air bag) which did not deploy as a result of the right front impact. The driver of the vehicle (28 year-old female) was not wearing the available, active, three-point, lap and shoulder belt. The driver was ejected out the backlight and was found just west of the Daytona's final rest position. She sustained fatal injuries including multiple lower left rib fractures and a massive hemothorax (i.e., estimated at between 2000-3000 ccs) which resulted in cardio-pulmonary arrest from exsanguination. The driver of the Daytona was listed on the Police Accident Report as sustaining a "K" (fatal) injury as a result of her crash. The driver (33 year-old male) of the Fiero was listed on the Police Accident Report as restrained and sustaining an "A" (incapacitating) injury.

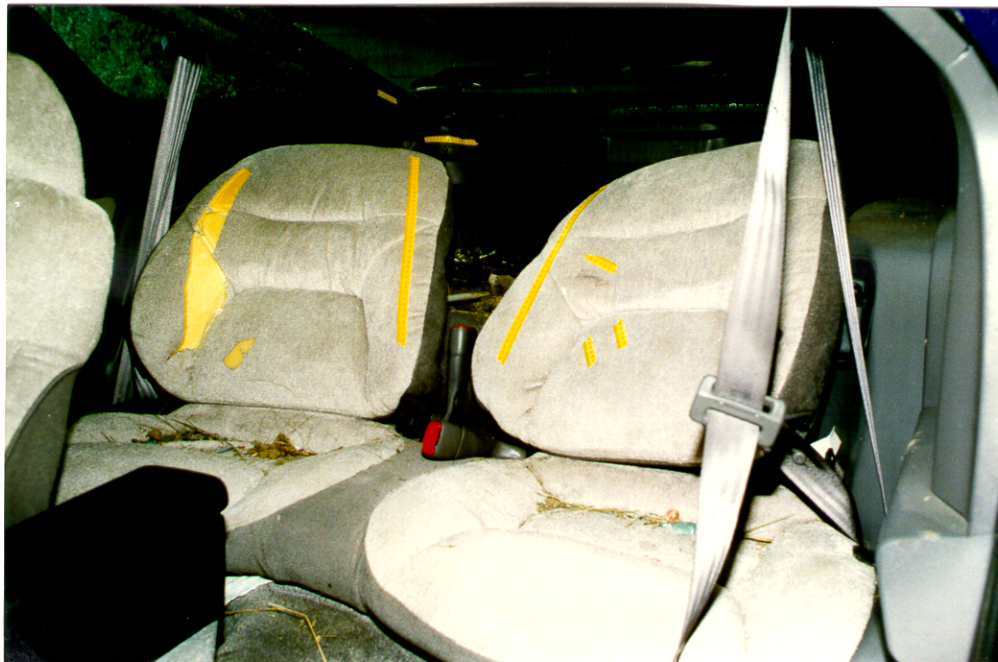
48 - [REDACTED] 1993
 [REDACTED], Illinois
 TRC/IU: 93-07, Task: 0103
 TRC Photo: rear seats bent
 by ejection-from driver area

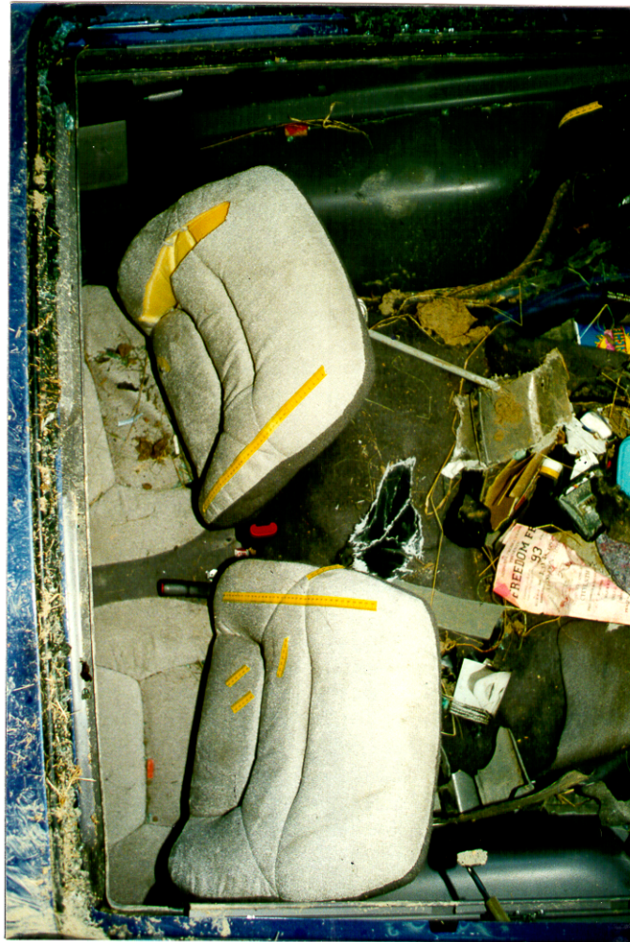
50 -- [REDACTED] 1993
[REDACTED] Illinois
TRC/IU: 93-07, Task: 0103
TRC Photo: bent rear seats
from back through backlight

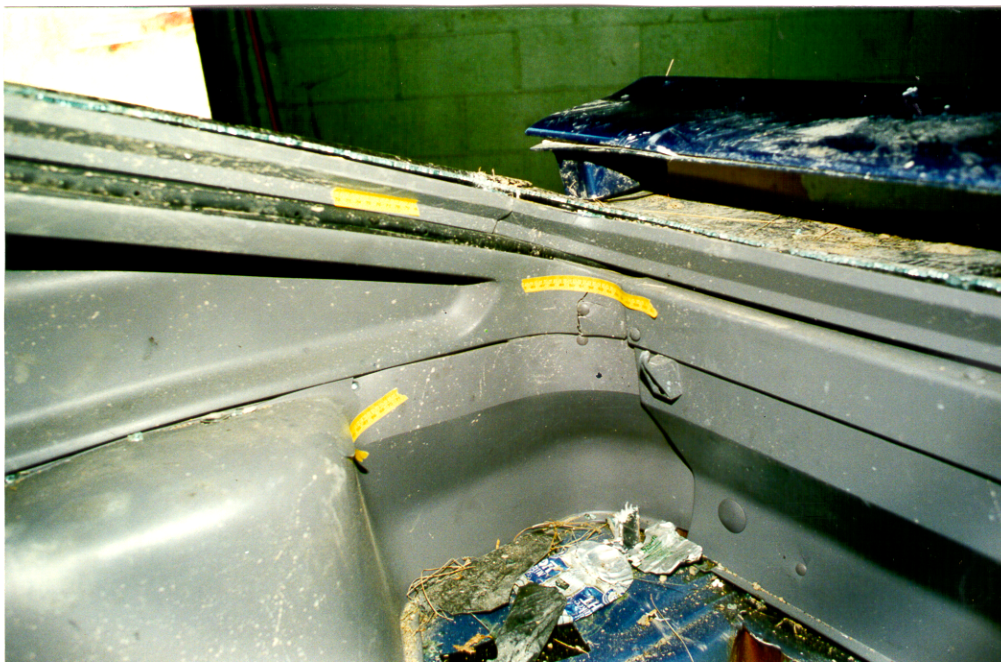
51 -- [REDACTED] 1993
 [REDACTED] Illinois
 TRC/IU: 93-07, Task: 0103
 TRC Photo: driver contact
 in right rear cargo area

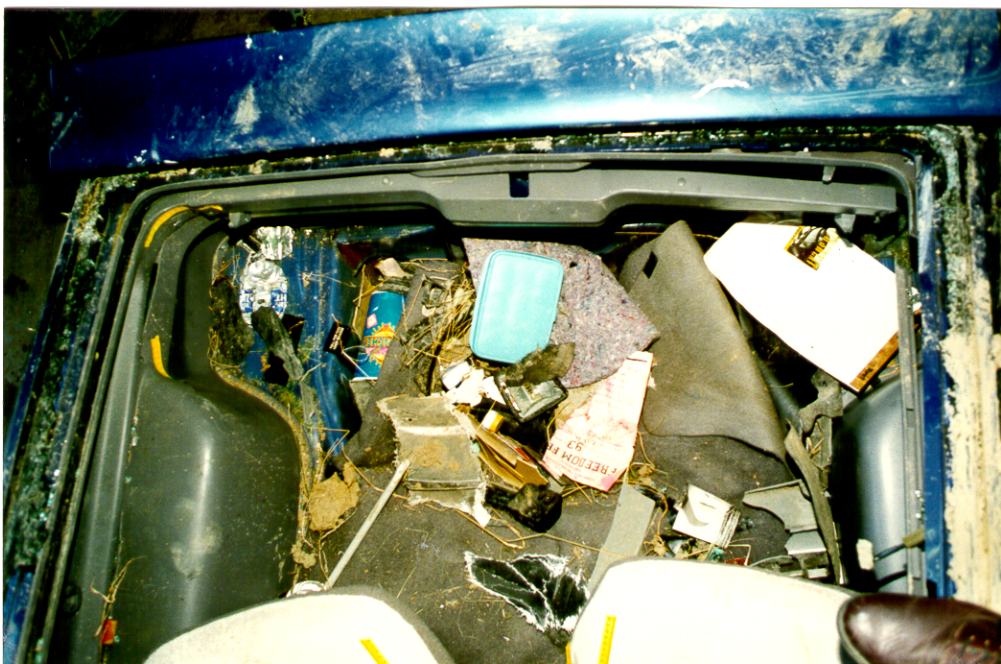
52 -- [REDACTED] 1993
 [REDACTED] Illinois
 TRC/IU: 93-07, Task: 0103
 TRC Photo: driver contact
 in RR cargo area from top
